MSC APOLLO 13 INVESTIGATION TEAM

FINAL REPORT

FLIGHT OPERATIONS
AND NETWORK

APOLLO 13

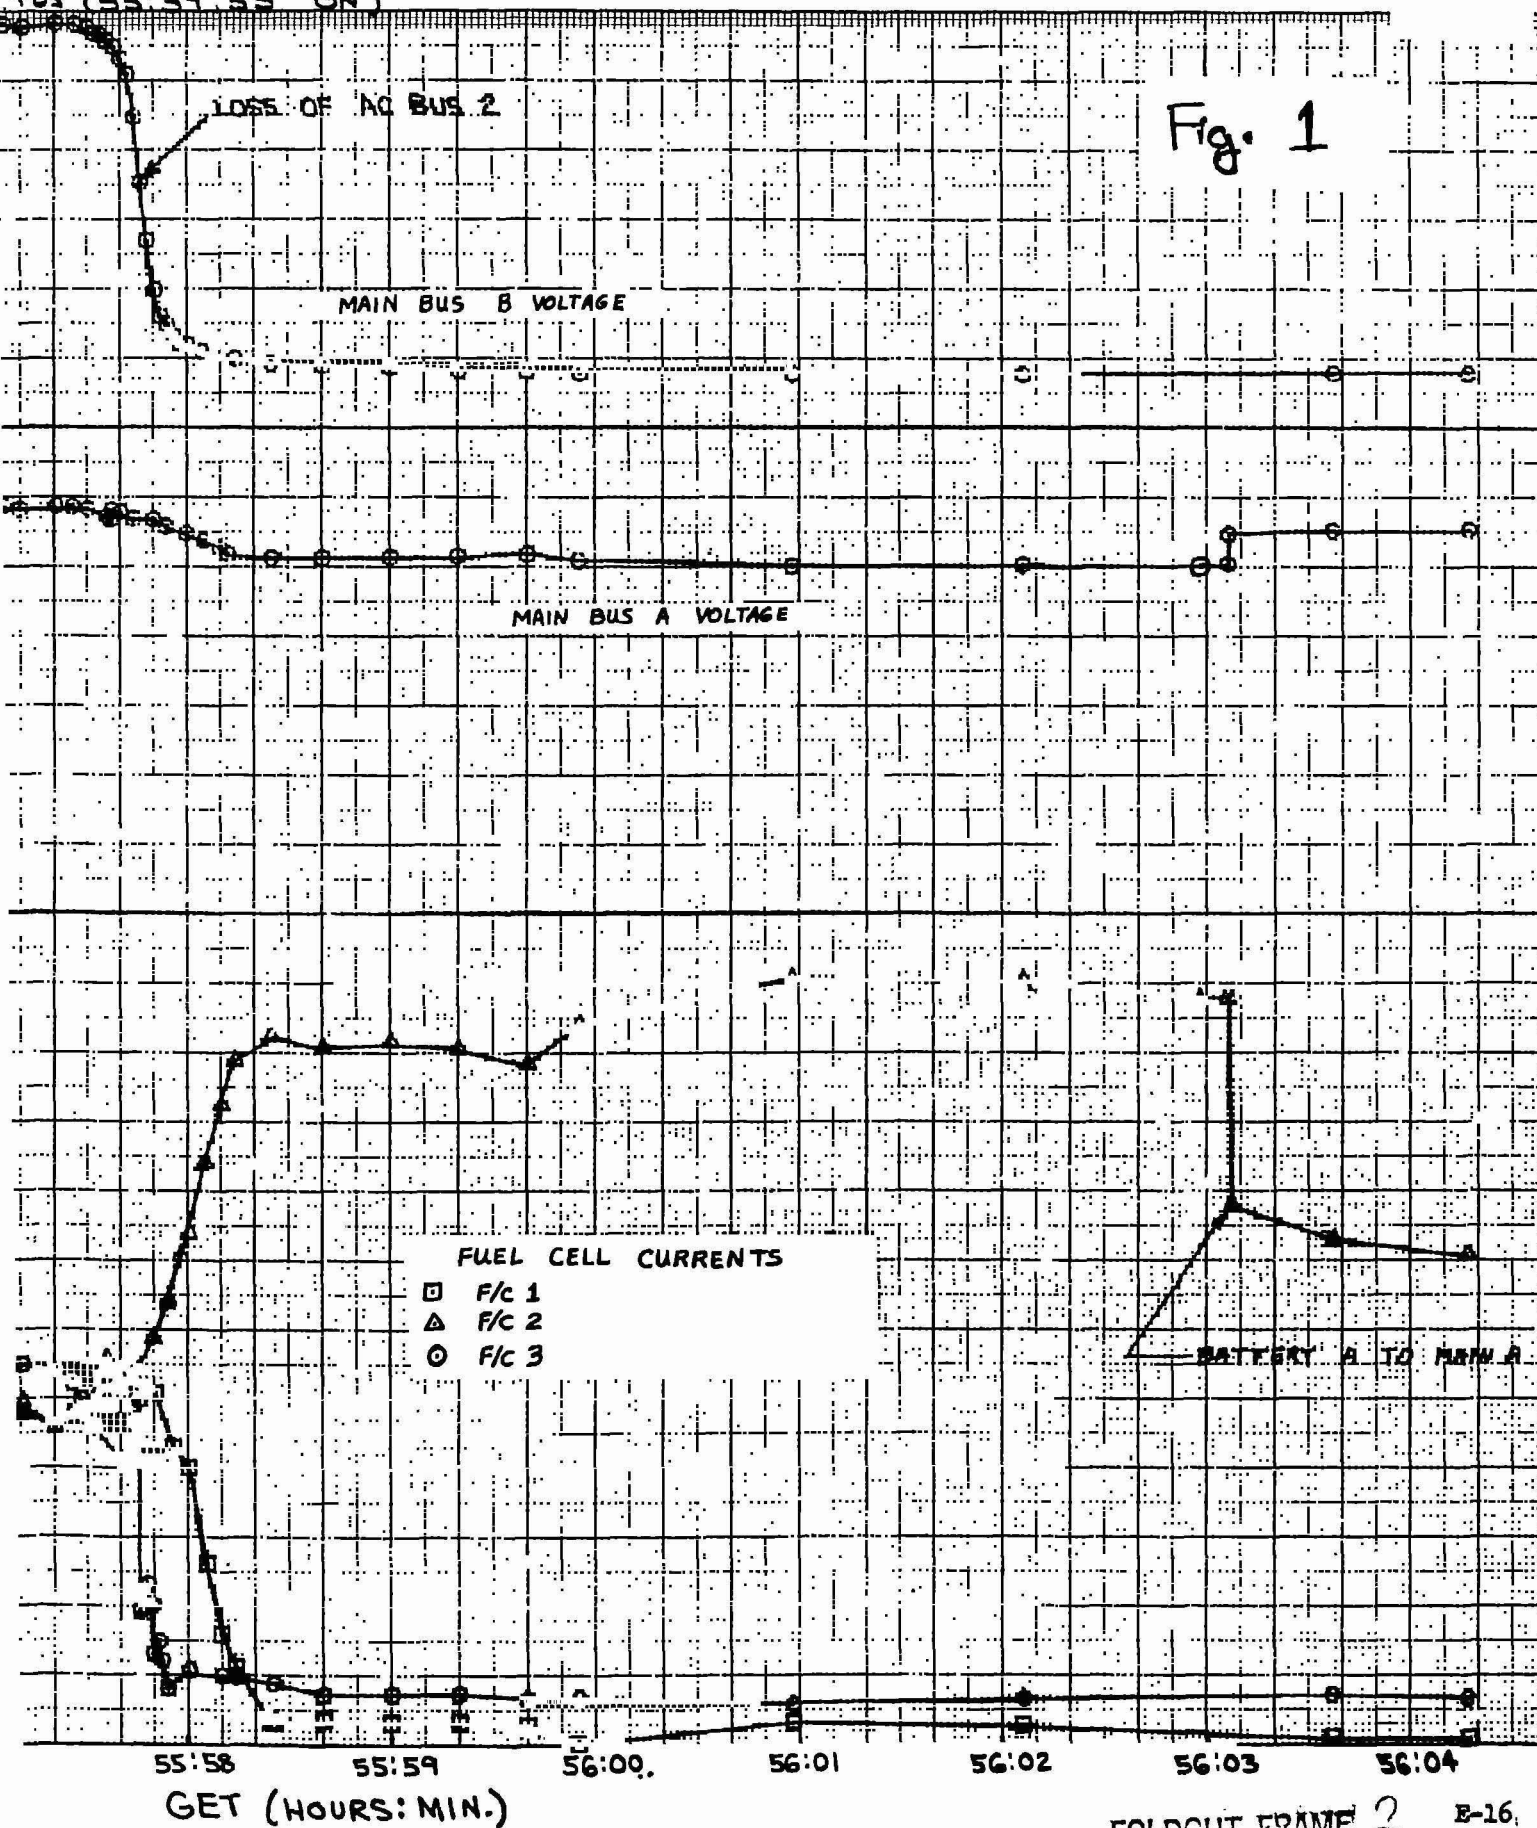
Fig. 1

Plotted From DLOGS (55:53:55 ON)
AND HARD COPIES (55:59:55 ON)
